MARINE SAFETY ALERT

Safety Alert 04-19

Confined Spaces: Silent & Invisible Killers

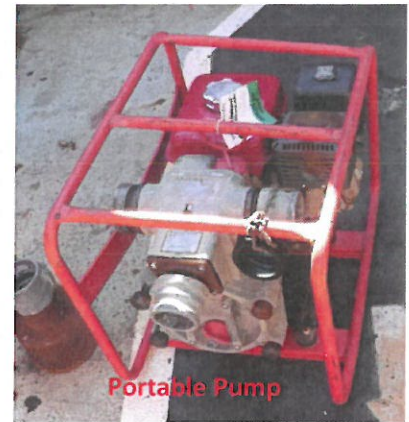
Each leg had six decks. The first two uppermost decks had access hatches that allowed easy transfer of crew and equipment between the decks. The remaining decks were accessed via manhole hatches that were too small to allow passage of the portable pump and had to be enlarged. As each ballast tank was fully discharged, the manhole cover at the bottom of the tank was enlarged and the pump was lowered. Once they reached the lowermost ballast tank, the pump was set up with its suction hose in the tank and discharge hose exiting the leg via a hole torched through its side shell plating. A second smaller hole was also cut to serve as an air supply vent.

Seven of the crew onboard were involved in the dewatering operation and this casualty. They were experienced mariners, but lacked MODU experience. The Superintendent, Captain, Rigging Master, Fitter, and an AB (AB2) were on a dinner break while another AB (AB1) and the Electrician were assigned to oversee the dewatering operation. Without notifying anyone, AB1 descended into the leg presumably to check the pump. The Electrician became concerned when he failed to see AB1 on deck and descended into the leg himself, only to find AB1 collapsed and unconscious near the pump. Although nearly overcome by the exhaust fumes himself, he was able to safely escape.

- Obtain the requisite level of knowledge and training of confined space entry procedures including emergency and rescue procedures;
- Ensure crews undergo periodic confined space training and participate in routine and practical onboard emergency drills;
- Verify all required confined space entry and rescue safety equipment is onboard, maintained, tested and fully functional; and
- Continually appreciate the dangers involved in confined space entry and educate yourself by further study. A good place to do this are the [reports found on this webpage](#) ¹
